Quality Assurance and Source Inspection

Contract #: 04-0120F4Cty: SF/ALA Rte: 80 PM: 13.2/13.9File #: 1.28**WELDING INSPECTION REPORT****Resident Engineer:** Siegenthaler, Peter**Address:** 333 Burma Road**City:** Oakland, CA 94607**Report No:** WIR-017485**Date Inspected:** 18-Oct-2010**Project Name:** SAS Superstructure**OSM Arrival Time:** 1000**Prime Contractor:** American Bridge/Fluor Enterprises, a JV**OSM Departure Time:** 1830**Contractor:** American Bridge/Fluor Enterprises, a JV**Location:** Job Site

WELDING INSPECTION REPORT

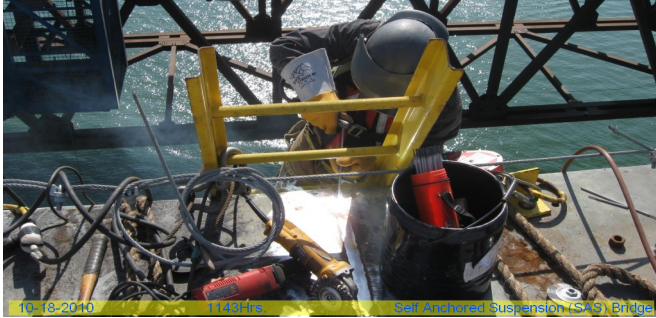
At OBG 7W/8W top deck plate 'A5' outside, ABF welder was observed Shielded Arc Metal Welding (SMAW) welding fill pass on the south end (150mm long) of the top deck splice joint. The welder was also noted tying in the top deck splice joint into the edge plate 'F' splice joint.

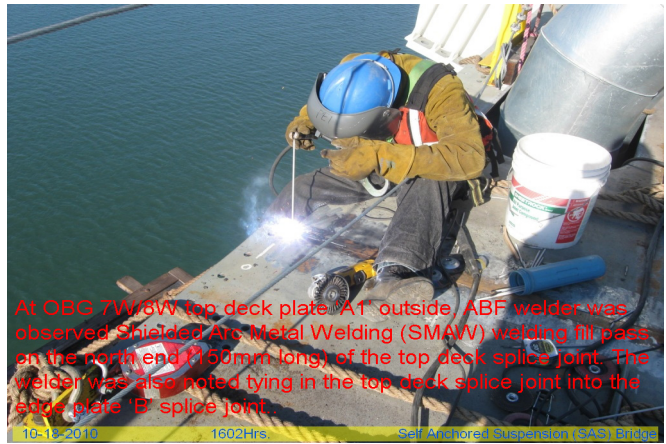
At OBG 7W/6W top deck plate 'A1' outside, ABF welder was observed Shielded Arc Metal Welding (SMAW) welding fill pass on the north end (150mm long) of the top deck splice joint. The welder was also noted tying in the top deck splice joint into the edge plate 'B' splice joint.

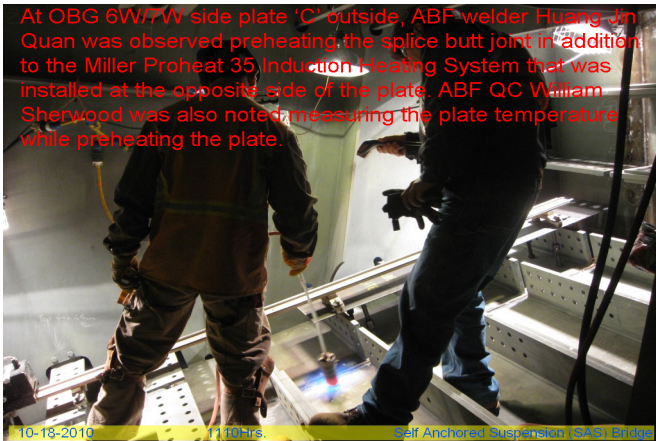
At OBG 6W/7W side plate 'C' outside, ABF welder Huang Jin Quan was observed preheating the splice butt joint in addition to the Miller Proheat 35 Induction Heating System that was installed at the opposite side of the plate. ABF QC William Sherwood was also noted measuring the plate temperature while preheating the plate.
